SUBJECT: Warranty Claims | R1

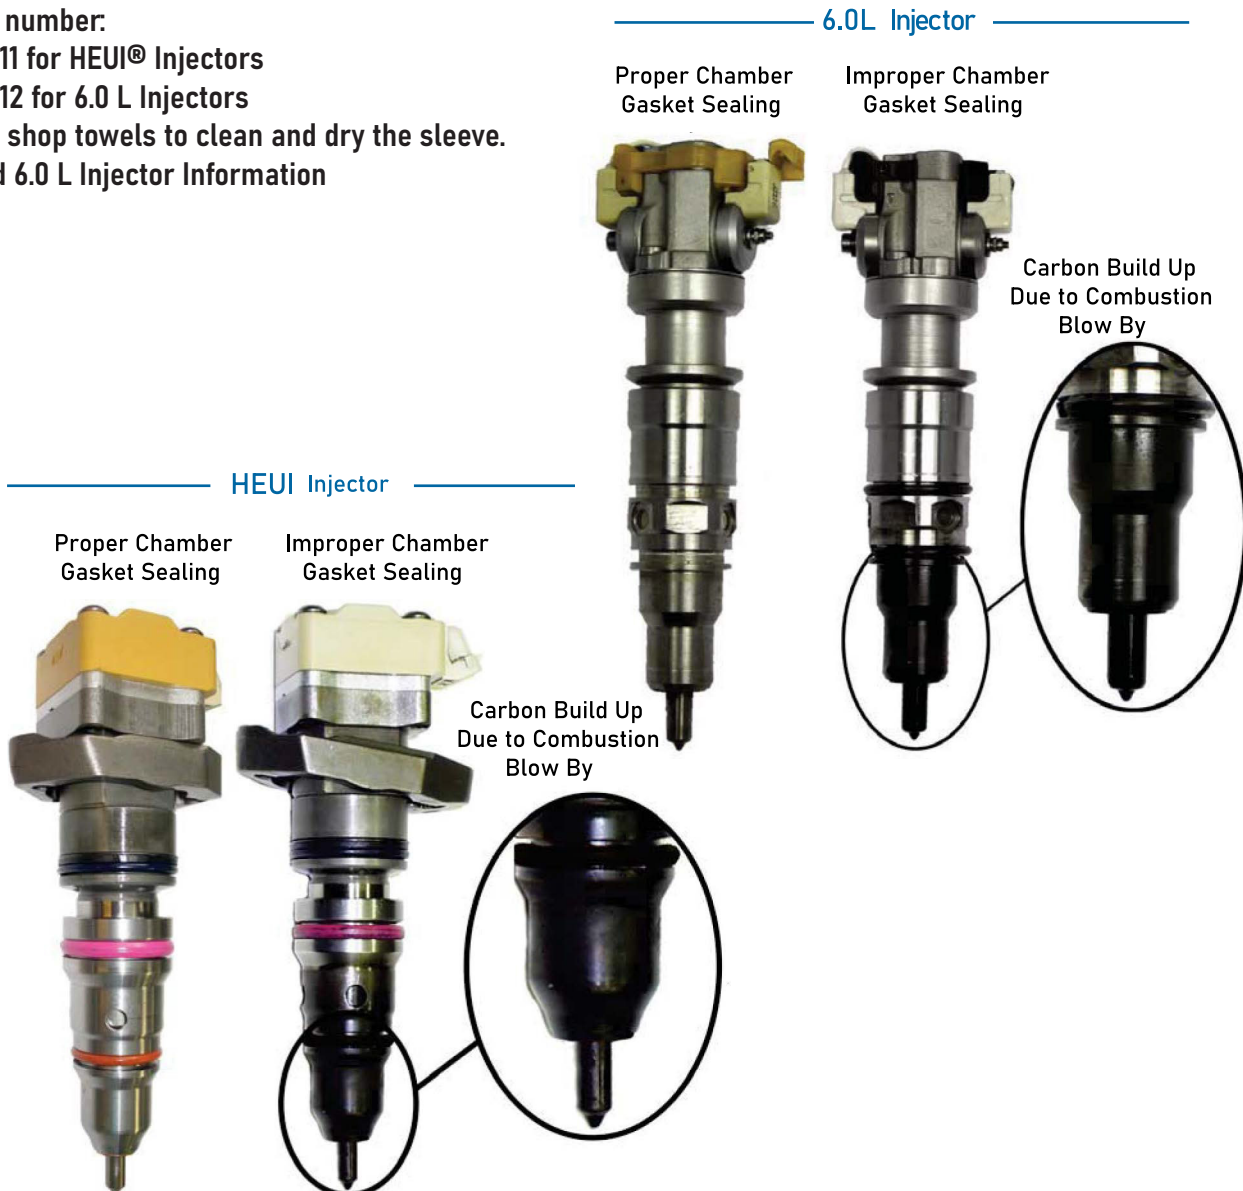
Alliant Power's warranty claim analysis continues to show "improper sealing of the chamber gasket" as the most common failure. This scenario results in combustion blow by which produces carbon build up at the base of the injector. The Alliant Power Warranty Policy specifically excludes failures caused by "...improper application, installation, or operation..." and the chamber gasket not sealing is the direct result of an installation problem.

The photos below clearly shows the difference between an injector with proper chamber gasket sealing and one that failed due to carbon build up produced by a poor chamber gasket seal. Please be aware that any injectors which visually exhibit the characteristics depicted below will automatically be rejected as warranty claims. The only way to avoid this type of failure is to properly clean the fuel injector sleeve before installing Alliant Power Injectors in an engine. To loosen and remove carbon materials, paying particular attention to the chamber gasket and injector O-ring sealing areas, we strongly recommend using solvent and a stiff brush, i.e., Rotunda/Owatonna

- 303-D111 for HEUI® Injectors
- 303-D112 for 6.0 L Injectors

Then use shop towels to clean and dry the sleeve.
