SUBJECT: International® I-6 HEUI® Injectors with Split Tip Failures

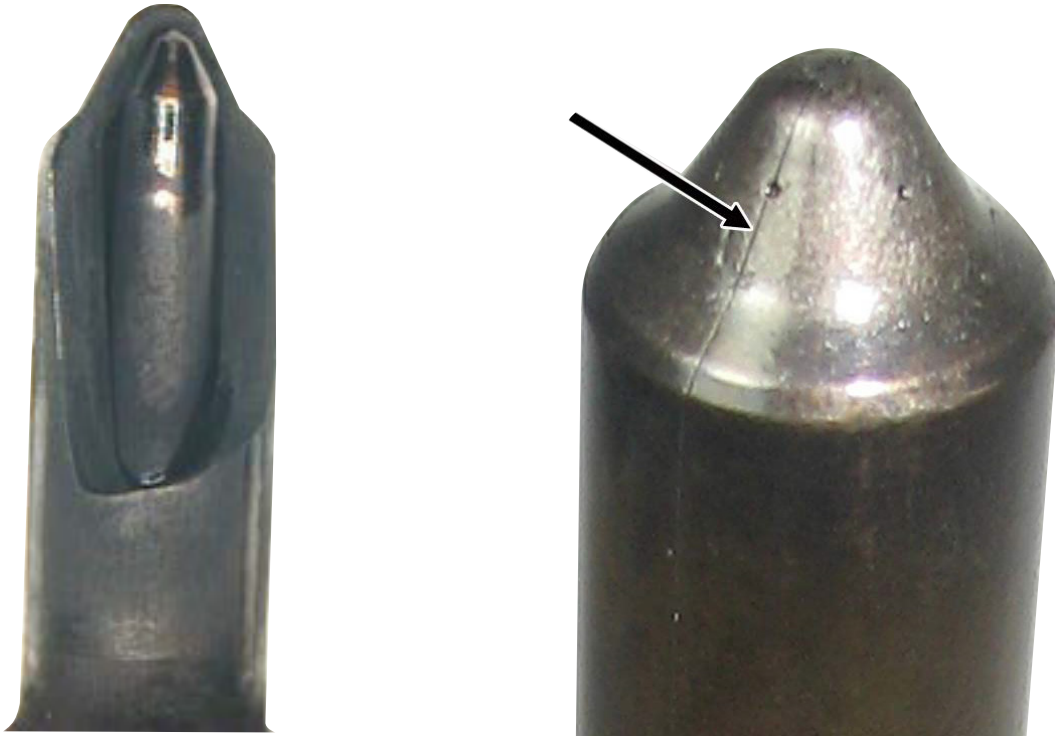
Without exception, we've found that I-6 HEUI split tip failures are the result of no fuel, low fuel pressure or the most likely cause, air in fuel. Under normal operating conditions, the pressure chamber of the nozzle valve body is completely filled, which provides a hydraulic cushion between the valve and valve body during each valve closure event. OEM engineers tell us any time the valve body pressure chamber is less than completely filled with fuel (i.e., under no fuel, low fuel pressure or air in fuel conditions), resulting in a loss of the hydraulic cushion, there's a risk the valve can strike the valve body violently and the tip can split.

Split tip failures resulting in pieces missing from the tip of the valve body are obvious (refer to top left photo); other times the split may be a hairline crack that requires sharp eyes or the use of a loupe to detect (refer to top right photo). In either case, we recommend your counter staff learn to recognize the failure and recommend appropriate action to your customer before replacing a failed injector, just as we've all learned to identify the cause of a seized hydraulic head in a distributor pump, and to fix the cause of the seizure before a new pump is installed.

Alliant Power Technical Bulletin APTB 03/04 includes a copy of a Navistar® bulletin issued to address priming I-6 engines when the fuel system is “dry” after engine service to avoid nozzle failures¹. Left unsaid in the bulletin, is that similar failures are just as likely to occur to a running engine that’s operated with low fuel pressure or air in fuel. Furthermore, we’ve observed anecdotally that split tip failures will continue to occur (no matter what brand injectors are installed) until the problem is corrected.

Standard diagnostic procedures apply if low fuel pressure (the specification varies with engine models) or excessive fuel inlet restriction (typically maximum 6” Hg at high idle) is measured (i.e., replace fuel filter, clean fuel strainer, check lift pump and overflow valve for proper operation).

- **Lift Pump** – If the suction side check valve of the lift pump is defective or held open by debris, fuel will drain back after a prolonged time, resulting in repeated “dry” starts.
- **Loom Clamps** – Chafing at any of the clamps which route the fuel inlet line, particularly the clamp(s) above the bell housing at the rear of the engine, can be sources of air.
- **Fittings** – Fitting points sealed by grommets can also be sources of air.

In addition to the procedures listed in the Navistar bulletin, when priming an I-6 engine that has a fuel/oil rail with a side fuel inlet connection, we recommend loosening the small fuel pipe plug at the front of the rail to bleed the system at its highest point.
