SUBJECT: GM® 6.6 L LB7 Duramax® Fuel Return Line Banjo Bolt

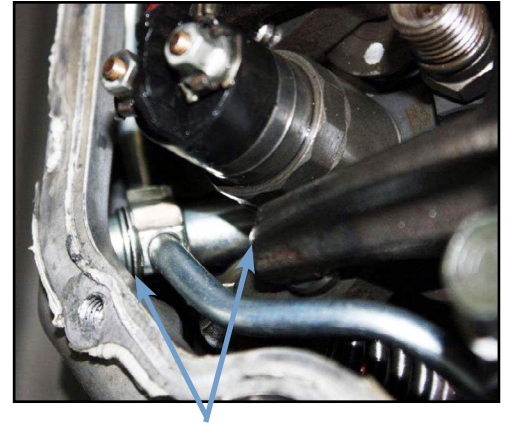
The fuel return lines on the 2001-2004½ GM 6.6 L LB7 Duramax are located under the valve covers and rocker housings. The return lines are connected to the injectors with banjo bolts. If the banjo bolts are not tightened properly they can cause return fuel to leak into the engine, diluting the engine oil with diesel fuel (possibly leading to severe engine damage). Accessing these bolts is time consuming and reusing damaged banjo bolts can be a costly practice in the long run.

**Return Line Leak Points**

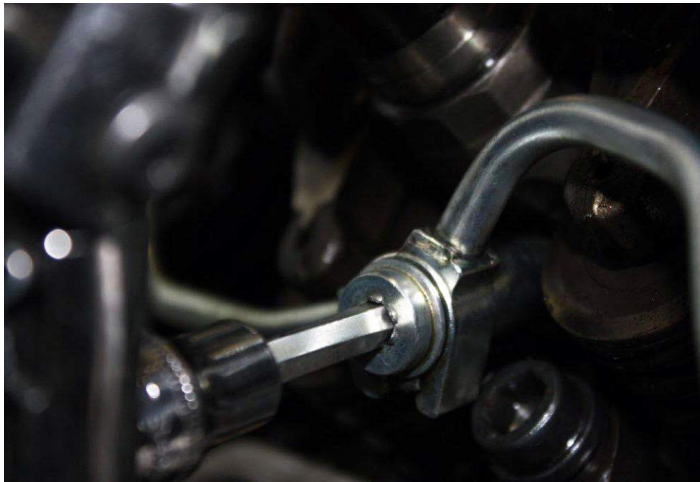
The fuel return line banjo bolt has a torque value of 12 lb-ft and requires a 5 mm Allen wrench to be removed and installed. The Allen head can be problematic and often strip, making it difficult to properly torque the banjo bolt on installation.

**Banjo Bolt Installation**

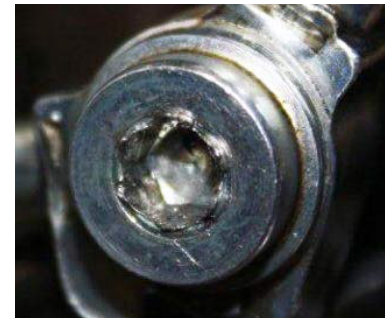
**Damaged Banjo Bolt**

Alliant Power recommends that all banjo bolts for the 2001-2004½ LB7 Duramax be thoroughly inspected any time they are removed. Replace using Alliant Power part number AP0059 if there are any signs of damage or stripping of the Allen head. Failure to do so can result in severe engine damage.
