**APTB 05/08**

**SUBJECT: 6.0 L Injector Connector Configurations**

**May 17, 2008**

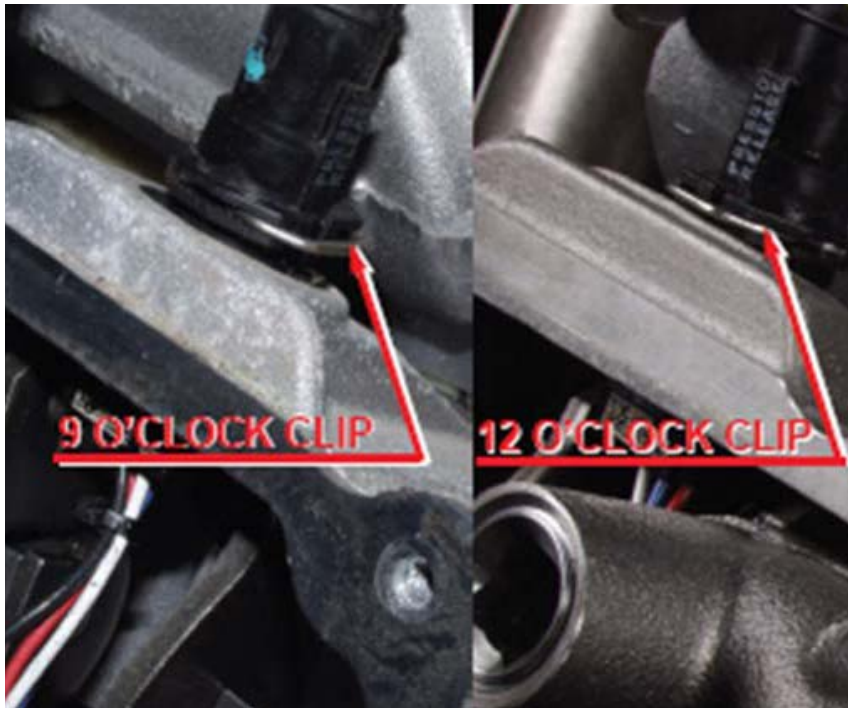
*Figure 1*

As a running change in model year 2003¼ engines, the orientation of the 6.0 L injector external connector retaining clip was changed to allow easier access during service. Prior to the change, the retaining clip was positioned on the side of the connector (9 o'clock). The new configuration positions the clip at the top of the connector (12 o'clock).

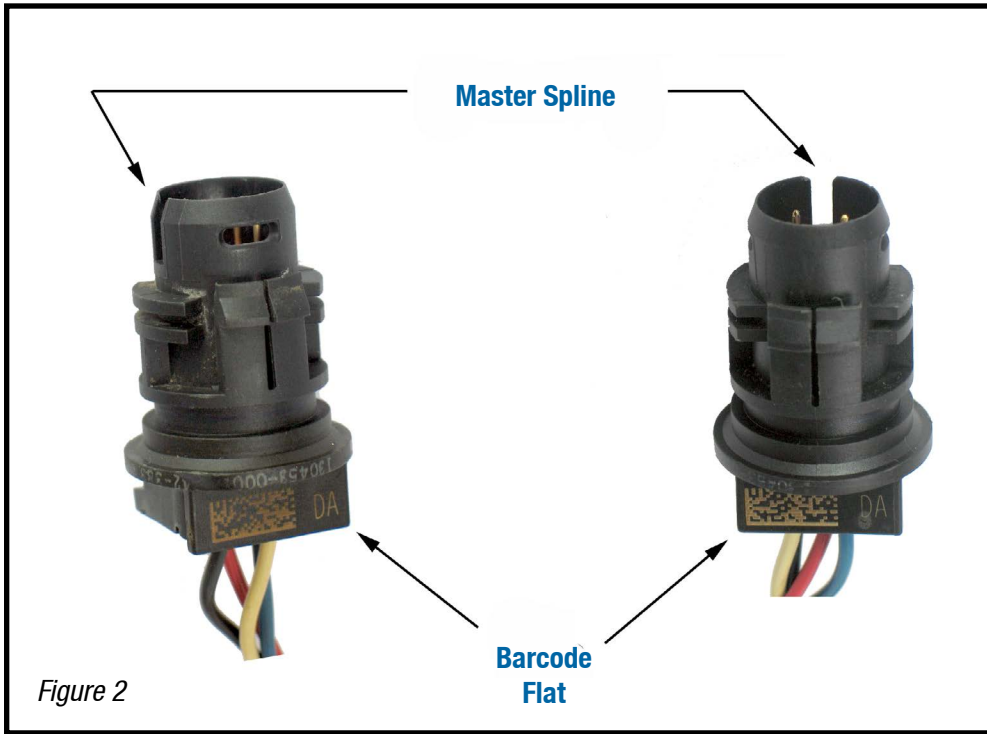
In conjunction with this change, the position of the barcode flat of the injector connector relative to the connector master spline was also changed. As shown in Figure 2, with injectors built prior to the running change, the master spline is at 9 o'clock when viewed from the barcode flat side. With injectors built after the running change, the master spline is at 12 o'clock when viewed from the barcode flat side. The position of the barcode flat relative to the master spline was changed to allow injector barcodes to be read easily during initial engine assembly. However, the barcode flat/master spline configuration has no effect on the operation of the injector. Remanufactured injectors may have either connector. The installer should not expect all flats within a set to have the same orientation when installed in the engine.

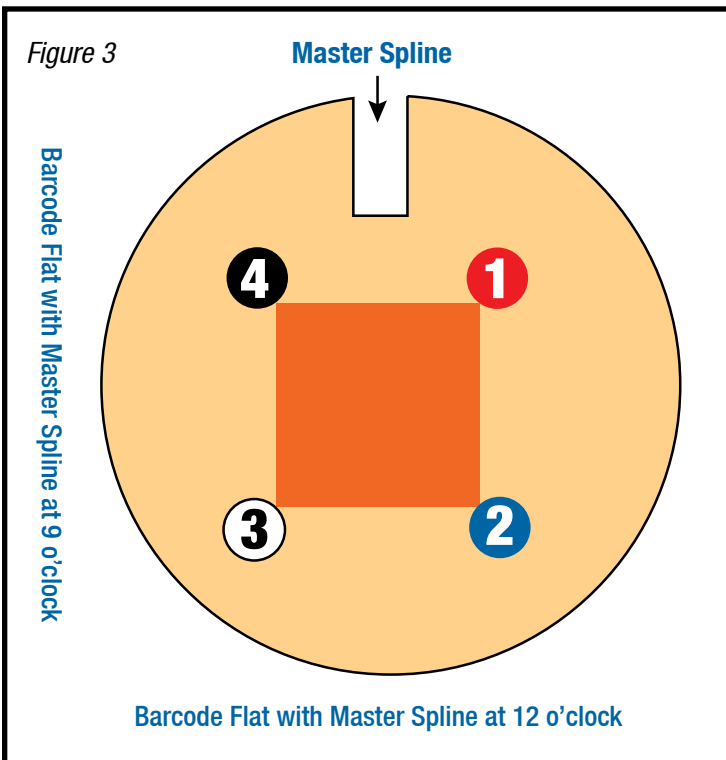
For reference, the line drawing (Figure 3) depicts the positions of the red (pin 1), blue (pin 2), white (pin 3) and black (pin 4) wires relative to connector pin numbers and the master spline.

**Note:** The relationship of the pins and wires to the master spline remains constant regardless of the position of the barcode flat.
