## APTB 01/09 R1

# SUBJECT: 6.0 L Injector Stiction Discussion and Recommendations January, 2009

Reference [TSB 08-26-3](#)

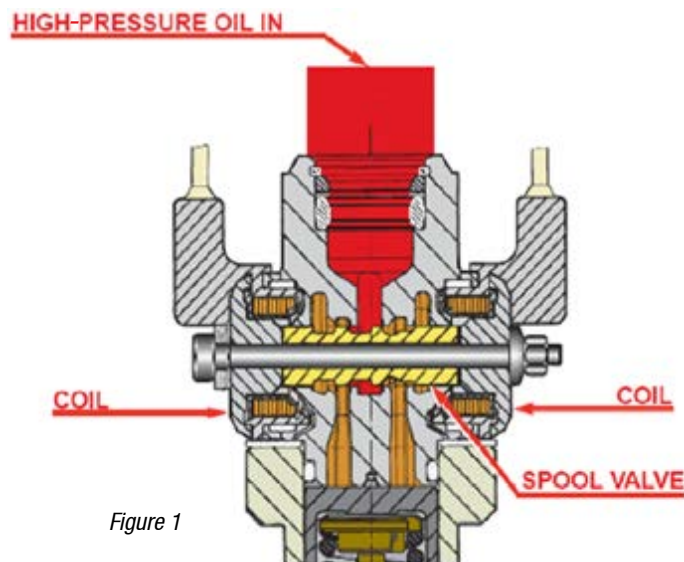
The spool valve is located in a bore in the stator housing; coils and coil housings positioned on both ends of the stator housing serve as end caps to seal the assembly and limit spool valve travel (0.432 mm). An open coil on one side of the stator housing and a closed coil on the other are alternately energized during engine operation to move the valve horizontally. The spool valve has two positions—movement of the valve positions the valve over drillings in the stator housing which either (1) allow high-pressure oil from the oil rail into the injector high-pressure oil pumping chamber, or (2) allow pressure in the high-pressure oil chamber to collapse and oil to exhaust from the injector. Open coil energization allows high-pressure oil into the high-pressure oil pumping chamber; close coil energization allows oil to exhaust from the pumping chamber; when neither coil is energized, the valve will remain where it was last positioned (in Figure 1, below, the close coil is shown on the left side, and the spool valve is in the closed position; also note the gap between the spool valve and the open coil on the right side).

As applied to 6.0 L Injectors, the term is used to describe the condition when static friction (i.e., stiction), in addition to normal static inertia, is greater than the force of either injector coil, resulting in a delayed spool valve response or a stuck spool valve. Stiction can be either a momentary or permanent condition, but is most often momentary. Because the spool valve is operating in an engine oil environment, stiction is usually temperature related increased oil viscosity as a result of cold temperature will exacerbate stiction causing conditions, leading to an increase in stiction severity; decreasing oil viscosity as the engine warms up often leads to a decrease of cessation of stiction symptoms.
