SUBJECT: Bosch® EPS 205 Maintenance & Troubleshooting Info

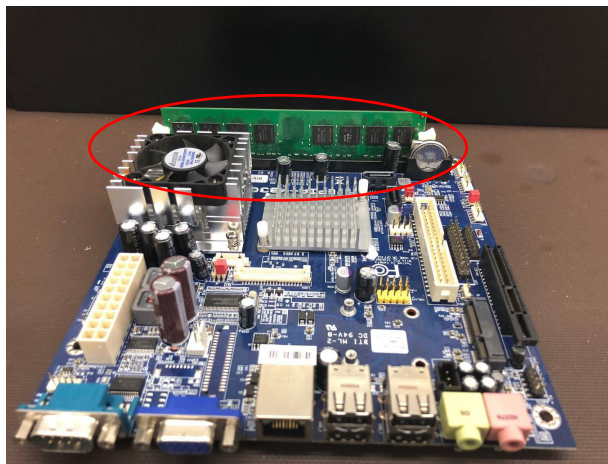
White Screen on Startup

This is a function of the age of the machine and can be caused by two things, oxidation on the connection pins of the RAM or a CMOS battery that has run down. Instructions for cleaning the RAM can be found in Bosch DSD SL 16-02 and CMOS battery replacement can be found in Bosch DSD SL 18-19. Following the instructions in both service letters will normally take care of the condition.

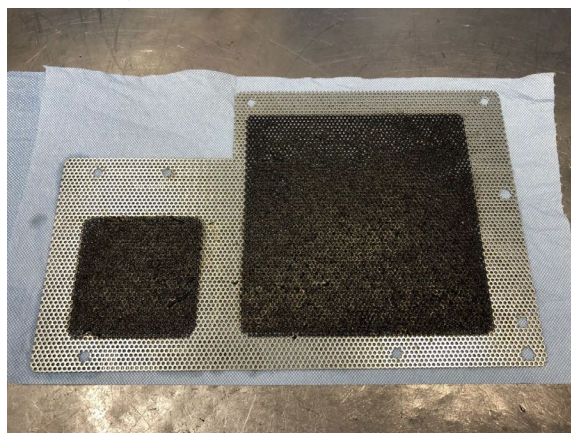
Overheating

Since EPS 205 cooling is dependent on airflow through the machine. Good clearance to a back wall is critical for this airflow. Bosch says there should be 10cm (4 inches) between the back of the EPS 205 and any wall or structure, the more clearance you can get here the better the cooling air flow will be. The second issue is there is an intake grill for cooling air located on the bottom of the machine. Through normal everyday usage spilled oil or oil from a blown HP hose will run down and collect on this grill. This oil residue will then collect dust and debris from the airflow through it. Bosch DSD SL 19-02 covers the removal and cleaning of this grate. We recommend that the grate be checked and cleaned as necessary at each oil change interval.

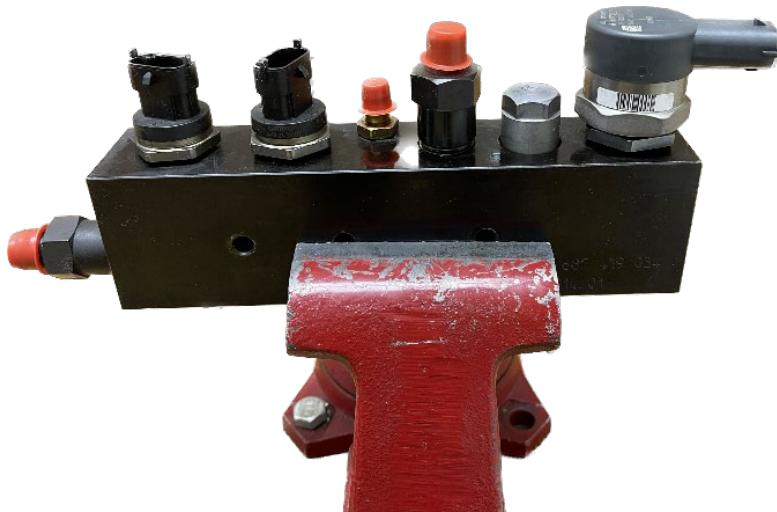
Inconsistent rail pressure or rail pressure relief valve opening

The issue here is the rail pressure will not maintain the desired pressure or you will hear the pressure relief valve pop off and rail pressure will drop. The problem is most always the pressure regulator valve. With time the regulator will start to accumulate deposits and get “lazy”, when this happens the pressure will fluctuate and not maintain the desired value. In some instances, it will fluctuate high enough to pop off the pressure relief valve. Just replacing the pressure relief valve will not fix the problem, the pressure regulator valve and seal will need to be replaced as well. Any time you are replacing components in the rail the rail must be removed from the machine and clamped in a vice as shown down below. Due to the fact the rail is mounted on rubber isolation feet getting the correct torque on the components with the rail still mounted in the machine is not possible. If the components are not torqued correctly the high-pressure fuel can leak and erode the sealing surface in the rail rendering it unserviceable.
