SUBJECT: Ford 6.4L & MaxxForce 7 Crankcase Dilution

When experiencing crank case dilution in the Ford 6.4L Power Stroke or the MaxxForce 7, these are the most common leak points.

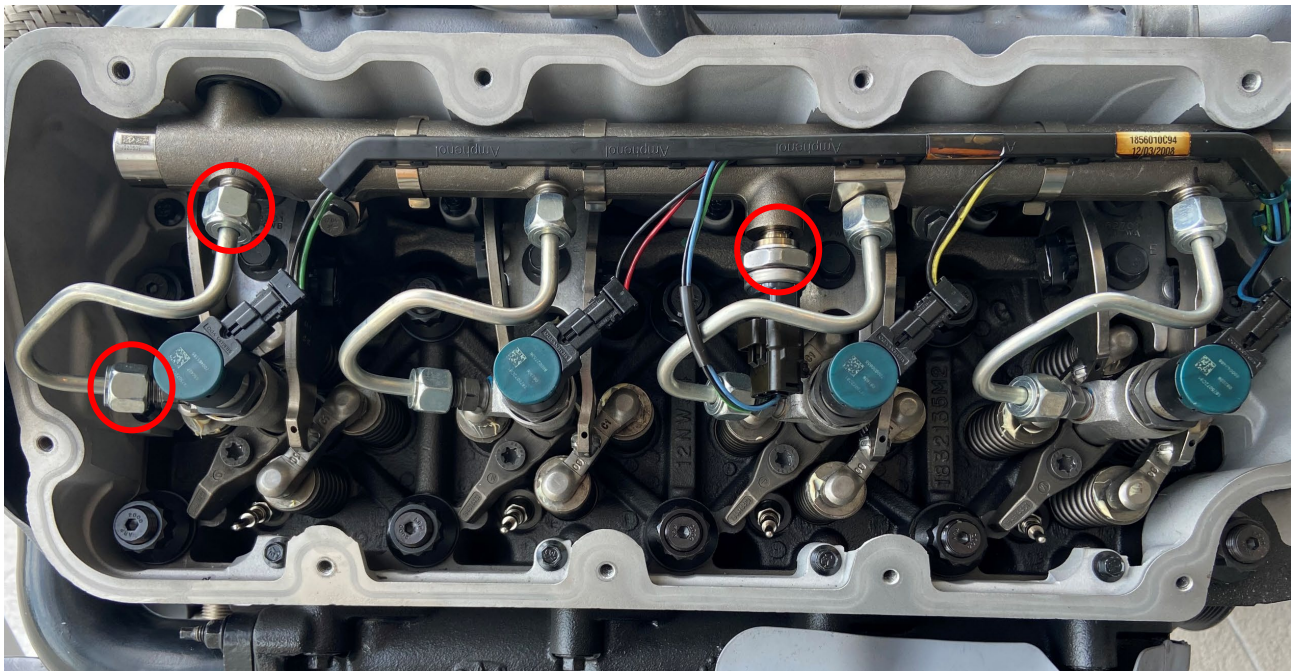
Fuel Injectors:

- If the torque specifications is not met on high-pressure rail to injector lines it will result in a leak. Failing to replace the high-pressure lines after loosening them can run the risk of crankcase dilution.
- Injector misalignment during installation can result in damage to the body O-Ring which over time can cause crankcase dilution. This is because the return circuit is pressurized.
- If an underlying aftertreatment issue causes constant regenerations, it will eventually lead to crankcase dilution. This happens because the ECU repeatedly demands post injections, which occur after the combustion event. Excessive post injections cause raw fuel to wash down the cylinder walls and into the crankcase.

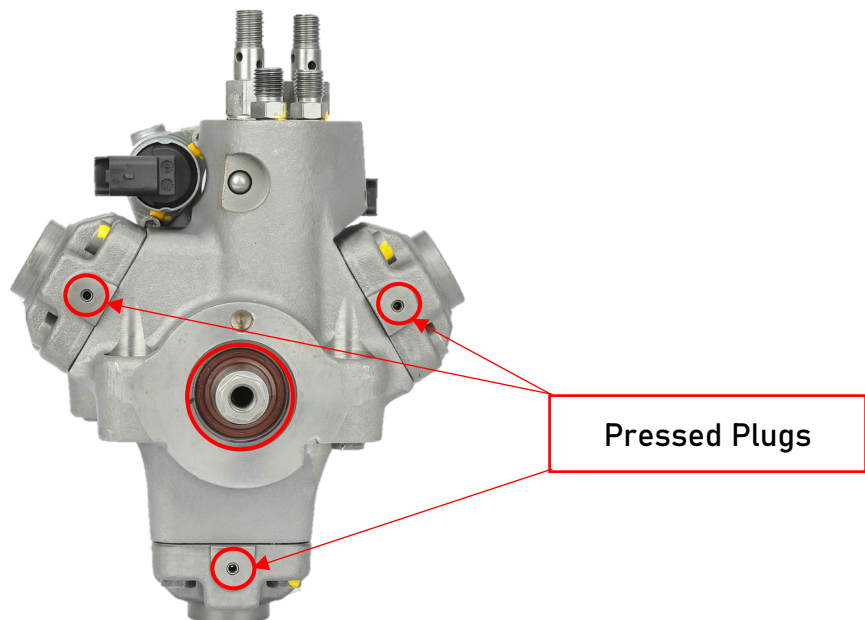
High-Pressure Fuel Pump (HPFP)

- There are a few known leak points that can lead to crankcase dilution. The areas known to leak are circled down below.
- Some pumps have been known to develop a fuel leak at the factory pressed plugs located at the ends of the pumping units. They have been mistaken as allen screw, but they are not. These plugs are factory-pressed and are not serviceable; if they leak, the pump must be replaced.

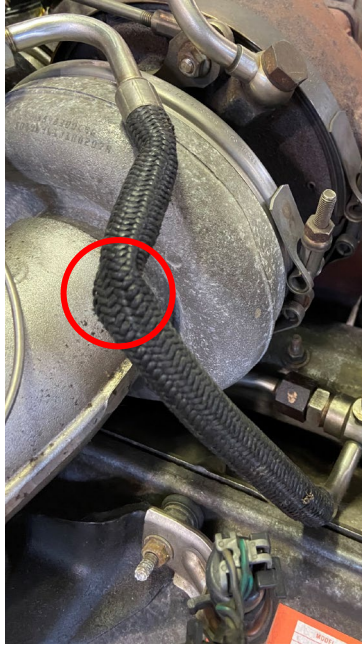
- On driveshaft seals we have seen two types of failures in the field: excessive wear on the drive shaft from the lip seal and ruptured or blown-out front seals. Excessive fuel return pressures can lead to the front seals being ruptured or blown out. The typical pressures in the return circuit range from 5-9 psi under various loads conditions. Excessive pressures can result in front driveshaft seal damage.
 - Common points of restriction include plugged fuel coolers, internal restrictions within the HFCM on the frame rail, and the pump/injector return line to the fuel cooler. We have frequently observed the pump/injector return line becoming kinked during service when fuel coolers are moved to the side (see image below).

Note: Alliant Power recommends checking for obstructions in the mentioned areas prior to completing a repair. Blown-out driveshaft seals caused by excessive fuel return pressure are non-warrantable through Alliant Power.
