APTB 03/08 R1

SUBJECT: 6.0 L Engine Stand Pipe and Snubber Valve Assemblies

March 7, 2008

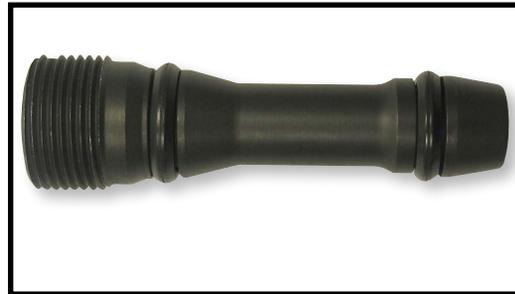
All three stand pipe configurations use a snubber valve in the high–pressure oil circuit to limit high–pressure disturbance or feedback from the injector. In Ford® literature, these valves are described as check valves but since they allow high–pressure oil to flow unimpeded in one direction and force the oil to flow through an orifice in the other direction, they're snubbers. As shown in the photo to the right of the valve in a 2005¼–2006¼ rear supply port plug (part of 5C3Z–9A332–A stand pipe/valve assembly), the assembly includes a spring, along with a powder metal snubber plate with three integral tabs to guide the plate in its bore and limit its travel.

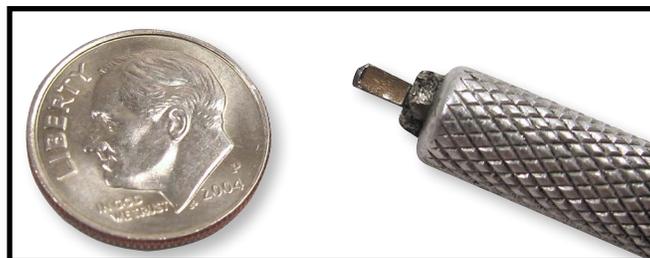
We've found pieces of broken off snubber valve tabs (attached to a magnet in the photo below) in the high–pressure oil inlet area of 6.0 L Injectors. This resulted in misfire complaints. After finding at least one broken tab, you need to determine if any other tabs are broken and if they are, that they're all accounted for. We suggest you disassemble the valves from both cylinder heads to determine how many tabs are broken off. If all tabs are not found in the injector(s), it is suggested you remove the rail end plugs and flush the rail to locate them.

Note: To replace valves on 2004¼–2006¼ models, you will need to buy the complete stand pipe/valve assembly: 5C3Z9A332A.

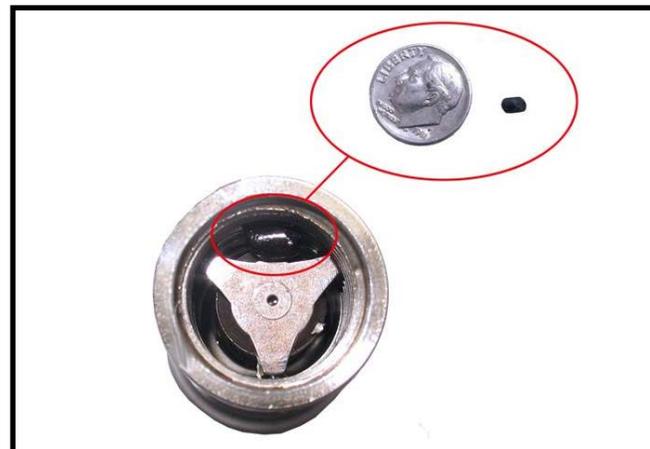
Debris in the snubber valve area can also lead to a driveability complaint. The non–ferrous piece shown in the photo at right (it appears to be a plastic fragment of the frame of the IPR valve screen or the high–pressure oil reservoir filter) was found in the snubber valve assembly of an engine that was being diagnosed for a flutter/vibration complaint on one bank. The position of the debris, wedged between the snubber plate and its bore, had no effect on the flow of the high–pressure oil inlet into the rail but prevented or reduced the snubber effect of the valve when ICP was reduced. Although no codes were present to lead the technician directly to this malfunction, in hindsight, we suspect the IPR duty cycle would show high variation at constant RPM.
