SUBJECT: AP0004 Engine Oil Cooler O-Ring and Gasket Kit

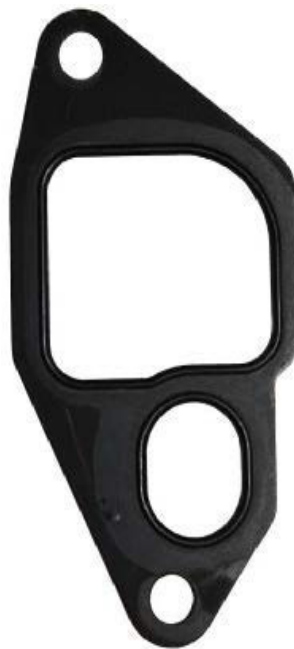
Original Style Gasket

Alliant Power is implementing a product improvement to the AP0004 Engine Oil Cooler O-ring and Gasket Kit. With input from the dealer network and testing by the Alliant Power Technical Department, we have found the gasket for the connection between the engine front cover and the front oil cooler housing does an inadequate job of sealing. The issue occurs during a cold start situation, with an external oil leak being the most common result. In extreme cases, oil in the coolant contamination has been reported.

Alliant Power has determined the material used to make the imbedded seal on the front gasket is the cause of the issue. From this point forward, the front gasket will be constructed from the same material as the rear gasket. The materials used in the rear gasket are proven to have superior sealing characteristics.

- The original style gasket is black in color with seal material that is also black with a round cross-section.
- The improved gasket is uncoated aluminum with seal material that is blue with a square cross-section.
