APTB 10/11

SUBJECT: G2.8 Remanufacturing Process

July 1, 2011

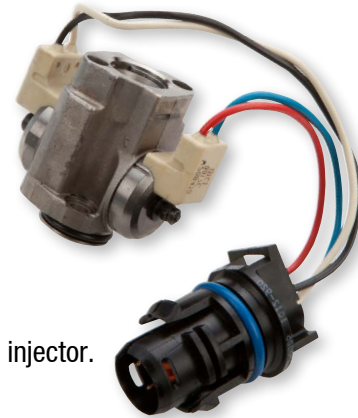
Coil Assembly

- The coil assembly is fully tested and inspected for any wire damage. If a coil is defective it is discarded.
- If a wire has a nick in the coating or if there are bare wires present, a wire repair is made using our patented repair process.
- The bullet connector is replaced with new as needed.
- The coil cross bolt and nut are replaced every time.
- All coil assemblies must pass testing both on their own and installed on an actual injector. Coils are reused or repaired as necessary to keep product cost down.

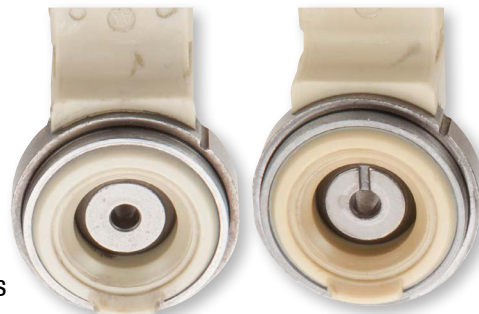
End Cap

- The latest version of OEM end cap production incorporates a slot on the surface with the intent of reducing “stiction.”
- Since Alliant Power is providing a remanufactured injector, some injectors will have an end cap with a slot and some without.
- At this point, there is no conclusive and consistent data that confirms the revised design cures all “stiction” related problems. Therefore, the slotted and non-slotted caps are treated as the same component in our remanufacturing process.
- “Stiction” related complaints have occurred on injectors with both styles of end cap.

For further “stiction” information refer to Alliant Power Technical Bulletin [APTB 01/09 R1](#).

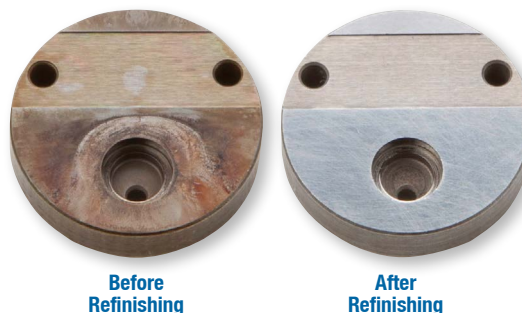
Disk Check Assembly

- The internal mating surfaces of the G2.8 injector seal high fuel pressures up to 25,000 psi.
- Improper surface finishes can result in internal leakage and poor injector operation.
- Alliant Power uses a precise refinishing process that restores sealing surfaces to OEM quality.
- All refinished pieces are measured for proper thickness; all pieces below minimum thickness levels are discarded.

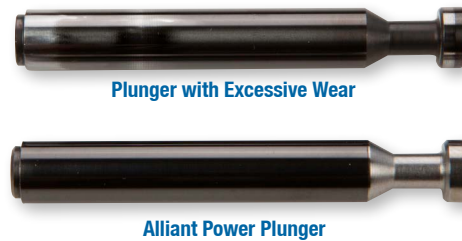
Intensifier Body and Plunger

- Each intensifier body and plunger is precision matched to tolerances within one micron. A mismatched set could lead to excessive leakage between components, which would affect injector performance.
- plungers that show wear are discarded.

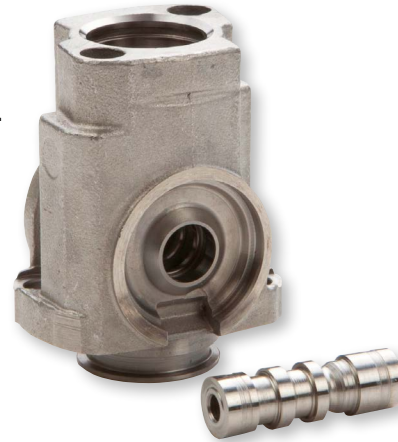
Control Valve Body and Spool

- Each control valve assembly is disassembled and inspected for reuse. It is examined for wear and any signs of damage/contamination.
- Each unit is tested for proper operation.
- If defects are found in either the body or spool, the assembly is discarded.

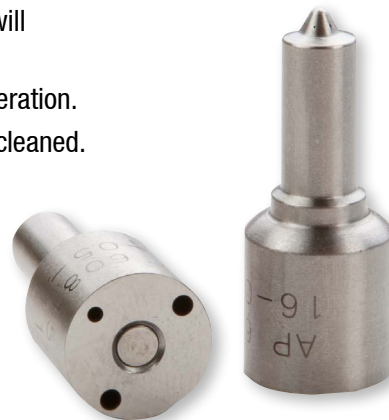
Nozzle Subassembly

- The nozzle subassembly on an Alliant Power Remanufactured G2.8 Injector will have either a remanufactured or new nozzle installed.
- Each of the nozzle subassemblies are 100% flow tested to ensure proper operation.
- Remanufactured nozzle subassemblies are disassembled and ultrasonically cleaned.
- The seat profile is resurfaced.
- The needle lift is measured for proper height and overall length of the nozzle is measured to ensure proper thickness.
- The subassembly is tested for leakage, opening pressure and proper spray pattern.
- Nozzle subassemblies that fail the above inspections or tests are discarded.

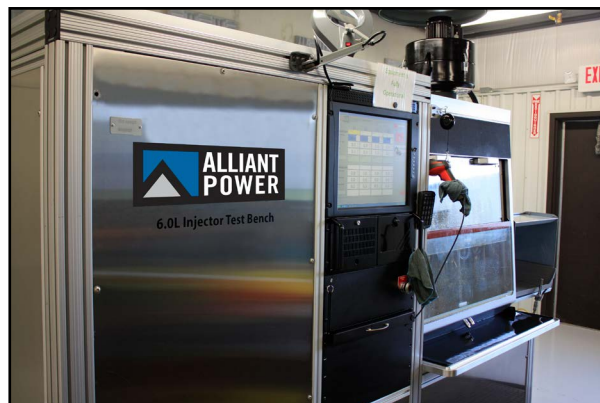
Injector Assembly

- An injector calibration procedure is performed on all Alliant Power Remanufactured G2.8 Injectors. This procedure runs the injector through multiple test steps on a proprietary bench, ensuring proper operation.
- The bench tracks each injector by serial number, capturing production date and flow rate data at the time of calibration.
